# Tugboat Rear Rebuild, Reinforcement and Protection using Belzona

ID: 8236

Industry: Marine  
Application: SOS-Ships and Offshore Structures

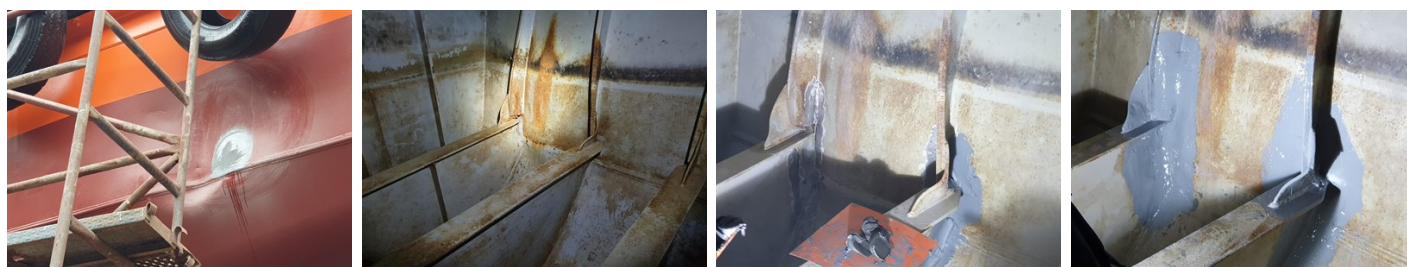
The Tugboat had sustained major damage during a dock manoeuvre. This resulted in a dock bumper perforating the external wall at the rear of the boat. This subsequently damaged the supports of an internal vessel storing a fire-retardant substance.

- \* Rebuild of the perforated wall ,
- \* Damage sustained to the internal vessel supports ,
- \* Rebuild & reinforcement to the supports ,
- \* Protective coating applied to protect the repair from future corrosion ,

The rear necessitated an external rebuilt of the perforated wall using Belzona 1111, it was then protected against corrosion using Belzona 5811. The internal vessel required internal reinforcing of its supports using Belzona 1111 to give strength and prevent potential leaks, the repair area was then coated with Belzona 5811 to protect against corrosion. The application was carried out in accordance with Belzona System Leaflet SOS-01 and SOS-02

would have been to weld the rear wall as well as add supports to the internal vessel. The confined area inside would have made the hot working extremely difficult as well as distort and leave the potential for micro-fractures to form. Due to the Belzona solution the repair was done in 4 hours and back in service 2 days later.
