# Belzona® SuperWrap II On-site Application for CUI

**Industry:** Oil & Gas  
**Application:** VPF-Valves, Pipes and Fittings  
**Substrate:** Carbon steel  
**Products:** \* Belzona 1111 (Super Metal) ,  
\* Belzona 1981 (SuperWrap II) ,  
\* Belzona 9381 (Reinforcing Sheet) ,  
\* Belzona 9382 (Release Film) ,

**Customer Location:** Taicang, China  
**Application Date:** January, 2017

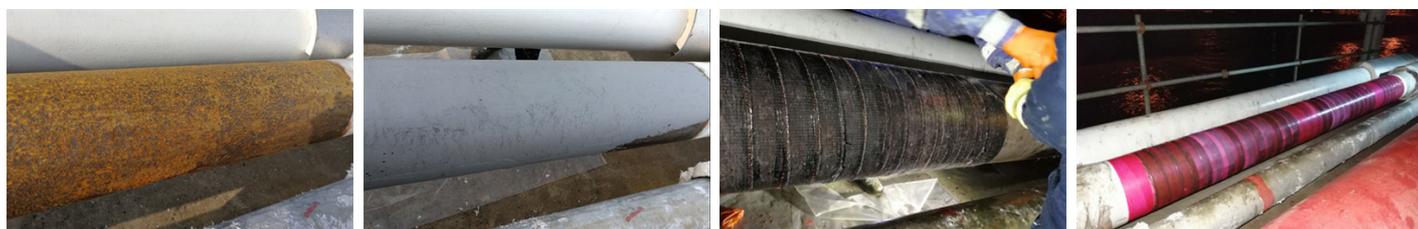
Corrosion under insulation(CUI).

\* 1. Damaged pipelines before application 2. Repair pitting spots with Belzona 1111 3. Multiple layers applied in accordance with designing requirement 4. Application complete before release film removal. ,

Application carried out in accordance with Belzona System Leaflet VPF-11 using Belzona SuperWrap II technology with installers, supervisors and designers who had been fully validated trained with this system. The first step is rebuilding corroded area by using Belzona 1111 to restore the original profile of pipelines. Then use Belzona SuperWrap II to restore and improve the strength of pipelines.
