# Belzona Protects Ice Breaker Research Ship

ID: 8246

Customer Location: Cape Town, South Africa  
Application Date: January 2020

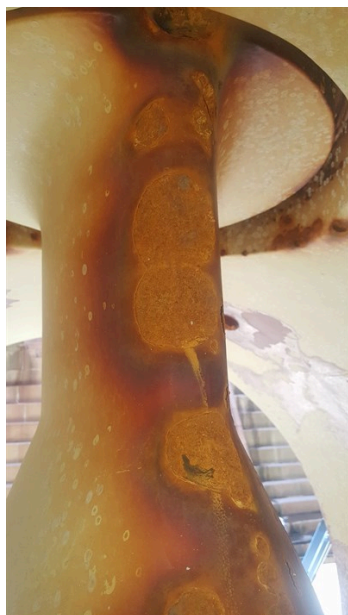
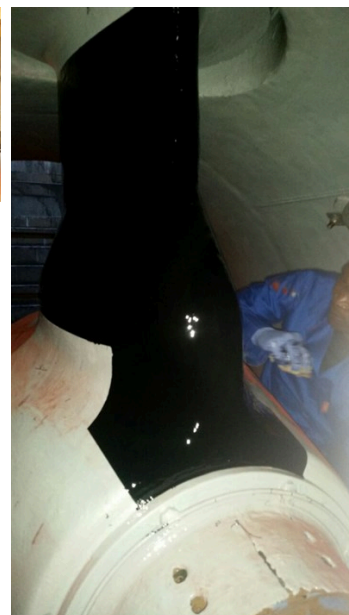
Areas and fixtures on the hull have been subjected to wear and erosion in service, leaving some of the steel exposed and open to corrosion.

- \* Repair area prior to application ,
- \* Detailed damaged area with steel loss ,
- \* Coating application complete ,
- \* Additional protection added to most severely affected areas ,

The application was carried out in accordance with Belzona System Leaflets SOS-01 & SOS-02.

The original corrosion paint has proven to be not strong enough to handle the harsh sea ice conditions. Belzona was chosen due to its erosion resistance and durability, to prevent costly damage in the future, while steel loss was still minimal. 192 sqm was covered in total.
