Belzona Protects Ice Breaker Research Ship

Industry: *Marine*
Application: *SOS-Ships and Offshore Structures*

Customer Location: *Cape Town, South Africa*
Application Date: *January 2020*

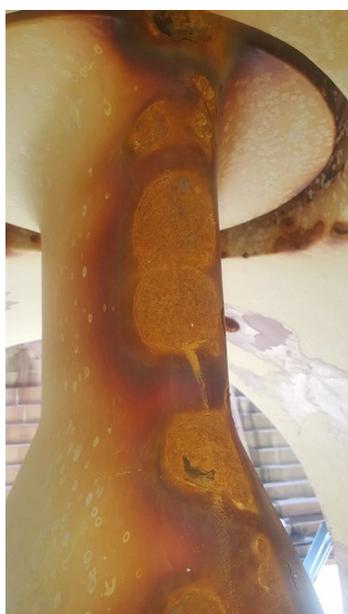
Areas and fixtures on the hull have been subjected to wear and erosion in service, leaving some of the steel exposed and open to corrosion.

- * Repair area prior to application ,
- * Detailed damaged area with steel loss ,
- * Coating application complete ,
- * Additional protection added to most severely affected areas ,

The application was carried out in accordance with Belzona System Leaflets SOS-01 & SOS-02.

The original corrosion paint has proven to be not strong enough to handle the harsh sea ice conditions. Belzona was chosen due to its erosion resistance and durability, to prevent costly damage in the future, while steel loss was still minimal. 192 sqm was covered in total.
