Belzona Protects Ice Breaker Research Ship

ID: 8246

Industry: *Marine*
Application: *SOS-Ships and Offshore Structures*

Customer Location: *Cape Town, South Africa*
Application Date: *January 2020*

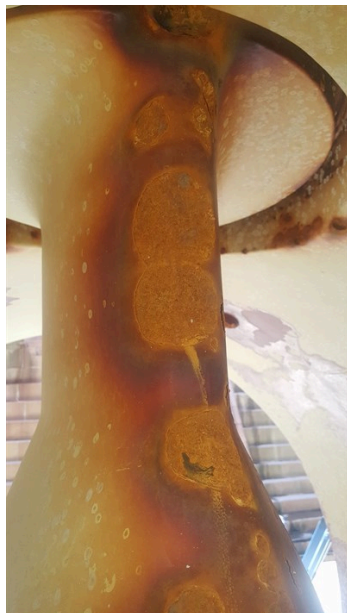
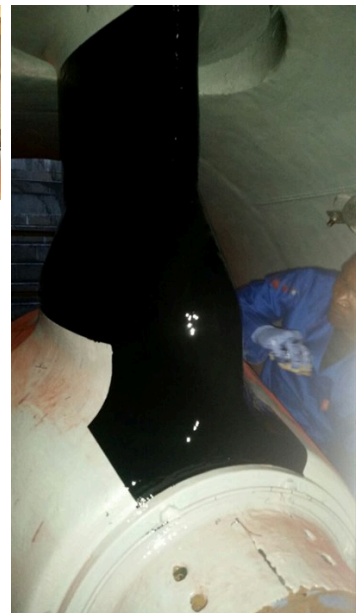
Areas and fixtures on the hull have been subjected to wear and erosion in service, leaving some of the steel exposed and open to corrosion.

- * Repair area prior to application ,
- * Detailed damaged area with steel loss ,
- * Coating application complete ,
- * Additional protection added to most severely affected areas ,

The application was carried out in accordance with Belzona System Leaflets SOS-01 & SOS-02.

The original corrosion paint has proven to be not strong enough to handle the harsh sea ice conditions. Belzona was chosen due to its erosion resistance and durability, to prevent costly damage in the future, while steel loss was still minimal. 192 sqm was covered in total.
