Hard wearing Belzona grip system installed on an airport walkway

ID: 8247

Customer Location: *Glasgow*

Substrate: *Concrete*

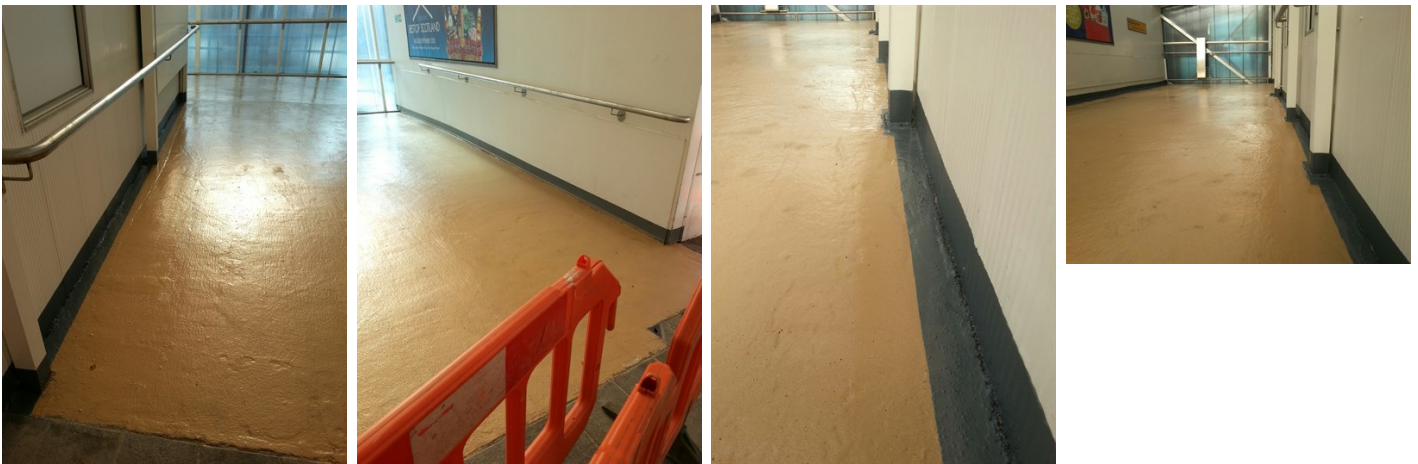
Photograph Descriptions

- * Belzona 5811 during application ,
- * Barriers keeping traffic away from the area ,
- * Belzona with aggregate applied ,
- * Cured system ,

The walkway was barriered off & the concrete was prepared using a floor grinder. Belzona 5811 was then applied as a two coat

system over the floor area. Belzona 9221 Surefoot aggregate was then applied ontop to provide positive traction for trolleys & pedestrians. Due to the low temperatures at that time of year & the limited downtime available external heating was used to warm the substrate & coating to force cure it in a short space of time.
