# Belzona Repairs Desulfurization and Denitrification Pump Casing and Provides Long-term Protection

ID: 8252

Customer Location: *Xianyang, Shaanxi, China*  
Application Date: *December 2019*

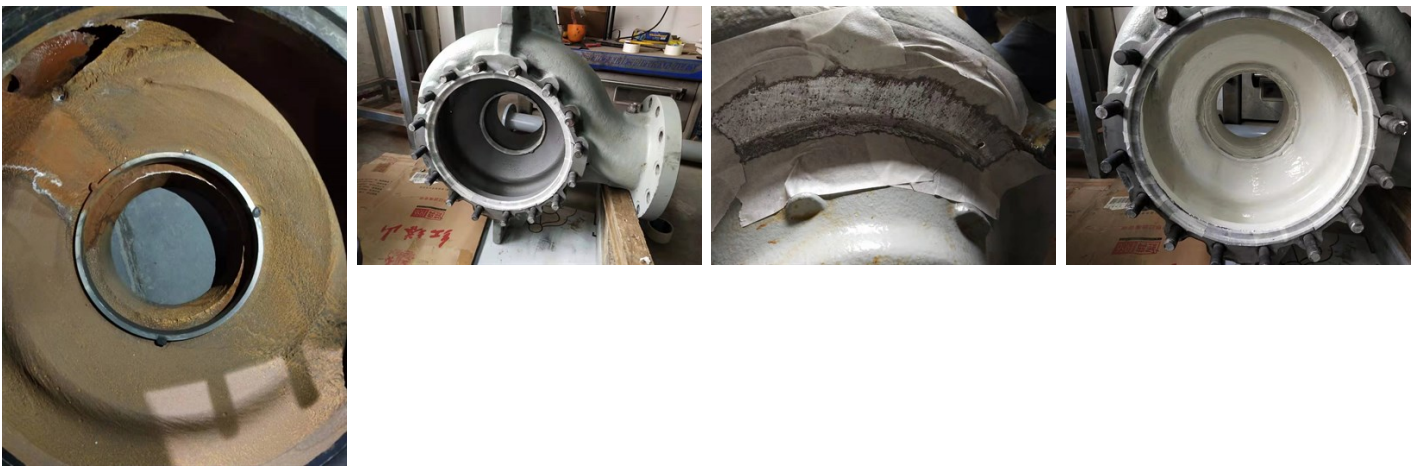
*Leaking pump casing and seriously corroded runner.*

- \* Damaged pump casing ,
- \* Gritblasting internal part of the casing ,
- \* Repair the leakage of the pump casing ,
- \* Application complete ,

The desulfurization and denitrification pump experienced chemical corrosion and erosion caused by corrosive media during the process of transporting fluid. Because of the lack of protection or failed anti-corrosion treatment, the pump was seriously corroded, which caused potential safety risks.

Application carried out in accordance with Belzona Know-How System Leaflet CEP-3 and CEP-5.

The asset owner used patch welding to repair the leaking pump previously which could only help for a short period of time. After using Belzona to repair and protect the pump, which requires a short application window, the leakage is repaired and the internal part of the pump casing was effectively protected for the long-term.
