# Belzona SuperWrap II Protects Pipelines for Chemical Plant

Industry: Oil & Gas  
Application: VPF-Valves, Pipes and Fittings  
Substrate: Steel  
Products: \* Belzona 1511(Super HT-Metal) ,  
\* Belzona SuperWrap II ,

Customer Location: Heze, Shandong, China  
Application Date: August, 2019

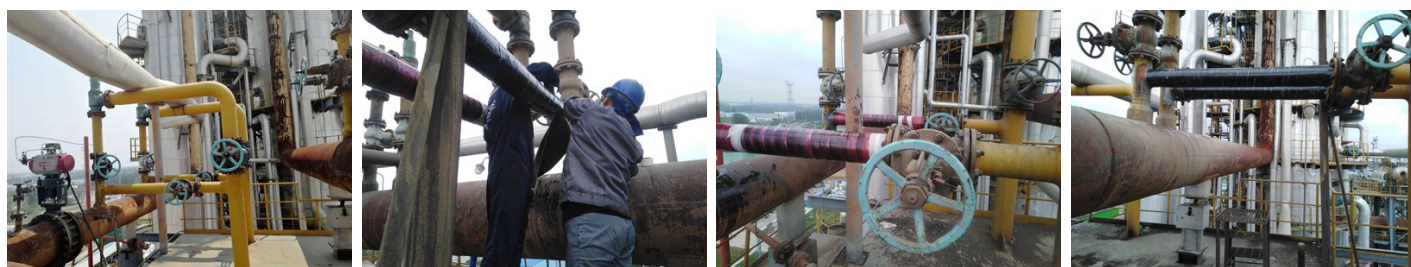
## Photograph Descriptions

- \* In-site conditions ,
- \* Wrapping application in progress ,
- \* Application of release film ,
- \* Application complete ,

Four DN150 safety valve auxiliary pipelines, designed for transferring oil, gas and water. The operating temperature is up to 150 °C , with a pressure of 0.3MPa. The initial wall thickness is 4.5mm, and the current regional thickness is 1.8mm. It is necessary to repair and reinforce the pipelines with reinforcing sheets. The length of each repair will be about 2 metres.

Application carried out in accordance with Belzona Know-How System Leaflet VPF-11. First, have the pipeline substrate prepared and cleaned to make sure it is clean, dry and rough; Then use Belzona metal repair material to repair the thinned and defected areas to restore the integrity of the substrate. Last, use the release film to wrap and consolidate the repair.
