Belzona Restores a Tank Roof in Hungary

Industry: Oil & Gas

Application: TCC-Tanks and Chemical Containment Areas

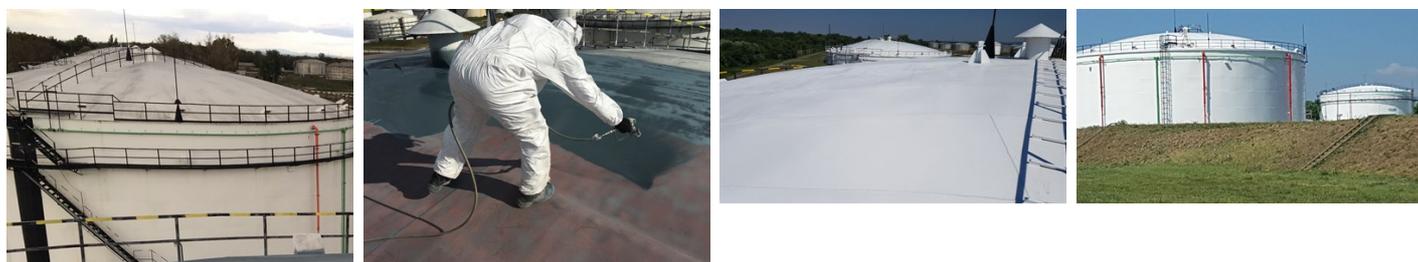
The tanks roofs were heavily polluted with a dirty grayed appearance generating higher temperature and so more evaporation of high volatile fuel in the summer period. This is a huge loss of product for the asset owner.

- * Polluted tank roof (before) ,
- * Belzona 6111 Liquid Anode used as a primer on the blasted surface. ,
- * Belzona 5111 Ceramic Cladding White was sprayed. ,
- * Condition check after 4 years. No problem, perfect performance. ,

The application was carried out in accordance with Belzona Know-How System Leaflet TCC-5.

Belzona 5111 Ceramic Cladding in white was chosen to provide a self-cleaning gloss white smooth finish avoiding further graying caused by pollution. A cost effective very fast application. The application took only 5-6 days and done by only 5 people.
