Belzona 1341 provides a non-stick coating to pump

ID: 8265

Industry: Water / Wastewater
Application: CEP-Centrifugal Pumps
Substrate: Steel
Products: * Belzona 1341 ,

Customer Location: Hungary
Application Date: 2016

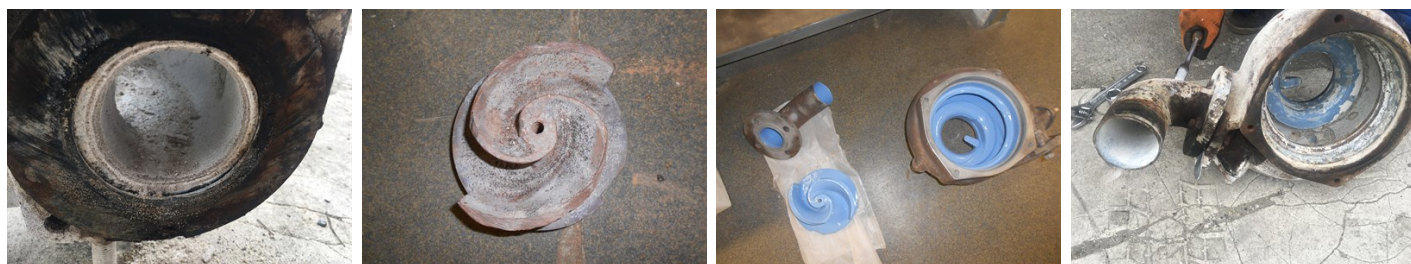
Photograph Descriptions

Clogging in pumps due to the high content of Struvite (aka MAP - magnesium-ammonia-phosphate) in wastewater. MAP is an alkali with PH9 so it is a corrosive agent as well. "Struvite can be a problem in sewage and waste water treatment, particularly after anaerobic digesters release ammonium and phosphate from waste material. Struvite can form a scale on lines and belts, in centrifuges and pumps, clog system pipes and other equipment including the anaerobic digester itself. Struvite, also referred to as MAP, forms when there is a mole to mole to mole ratio (1:1:1) of magnesium, ammonia and phosphate in the wastewater. Having struvite scale in a wastewater treatment system can lead to great inefficiency within the plant or operation due to clogging of the pipes, pumps and equipment. There have been a few options to solve this issue, including replacing the pipes, or using a hydro-jetter or a mechanical grinder to clear them. But many lines can be underground and either of these options implies considerable downtime and labor."

- * MAP residue in pump inlet ,
- * Cleaned impeller ,
- * 1341 applied ,
- * After 2 years in service there is only cleaning and refurbishment of the coating is needed. ,

A thorough removing of clogged material followed by salt removal washing process and blasting to achieve the right cleanliness and

roughness of the surface. Belzona 1341 Supermetalgilde was applied in 2 layers according to the instruction for use and Belzona System Leaflets CEP-3/CEP-10

The clogging was a problem in every 2-3 weeks. Application made in 2016. The pump came back for re-coating after 2 years continuous service. Belzona 1341 is in a good condition except some damages due to the mechanical cleaning by operators. The plant saves a lot of money and downtime as they need only 3 days in every other year to re-coat the pump.
