# BELZONA KEEPS DECKING SAFE

ID: 827

Industry: *Buildings & Structures*  
Application: *FPA-Floor Problem Areas*  
Substrate: *Wood*  
Products: *\* Belzona® 5811 (Immersion Grade) ,*  
*\* Belzona® 9211 (Supergrip Aggregate) ,*

Customer Location: *Holiday Village, Penrith*  
Application Date: *2002*

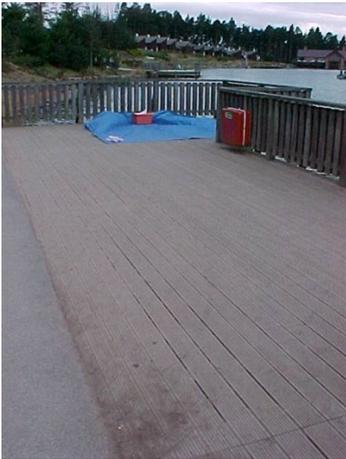
*Slipping hazard, particularly when wet. Also wear on top surface.*

- \* Slippage problem area. ,
- \* Belzona grip system was mixed and piped using polyethylene bag, and then spread with an applicator. Further aggregate was then spread over the area. ,
- \* Completed application. ,
