# Impeller Refurbishment Completed by Belzona

Application: CEP-Centrifugal Pumps

Eroded pump impeller.

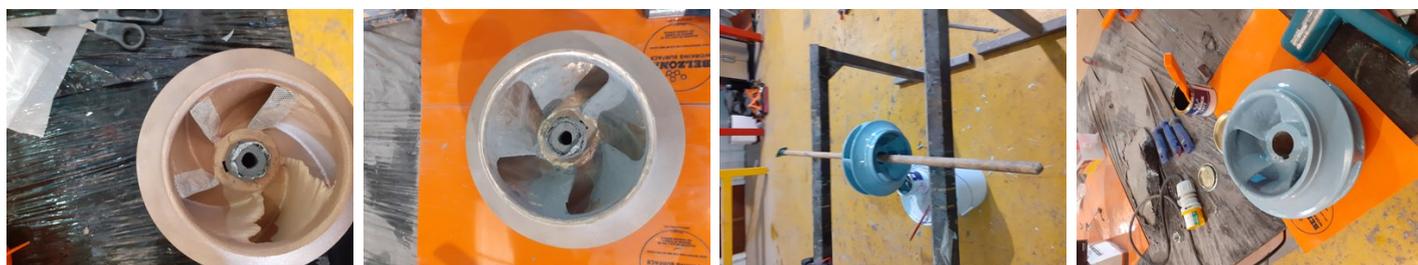
The impeller had eroded over time and now required re-profiling and a protective coating to protect the surface from the potential erosion in the future.

- \* Rebuild in progress to blasted impeller ,
- \* Impeller rebuild completed ,
- \* First coat of Belzona 1391T completed ,
- \* Completed Belzona repair and protection application ,

The substrate was prepared by conventional grit blasting to a minimum surface profile of 75µm and a surface cleanliness of SA 2½. The damaged areas were then rebuilt and re-profiled back to original using Belzona 1111 . Once rebuilt, two coats of our Belzona 1391T were applied in accordance with Belzona Know-How System leaflet CEP-03.
