# BELZONA KEEPS ENTRANCE WAY NICE AND SAFE

ID: 828

Industry: Buildings & Structures  
Application: FPA-Floor Problem Areas  
Substrate: Wood

Customer Location: Theme Centre, Doncaster, UK  
Application Date: 2002

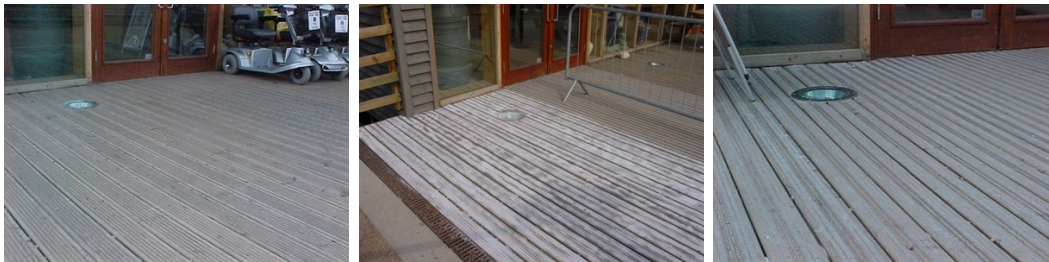
*Slippage problem, especially on the main entrance of the building. The client had tried unsuccessfully to combat the problem by nailing chicken wire to the timber decking, which caused extra trip hazards.*

- \* Slippage problem area. ,
- \* After masking 2 out of 6 grooves, Belzona® 5811 was mixed with 50% aggregate applied. ,
- \* Masking being removed from completed application. ,

The application was carried out using a modified version of the Belzona Know-How System Leaflet FPA-8. The Belzona® 5811 was mixed with 50% of Belzona® 9221.

Following this initial area being treated a water spillage occurred half on the decking and half on the Belzona Deck Grip. It was noted that the timber decked area was extremely slippery and hazardous whereas the area covered with the Belzona Deck Grip gave excellent grip properties even when soaked with water.
