# Belzona 1251 Prevents Major Plant Shutdown

ID: 8281

Customer Location: *Western Australia*  
Application Date: *May 2020*

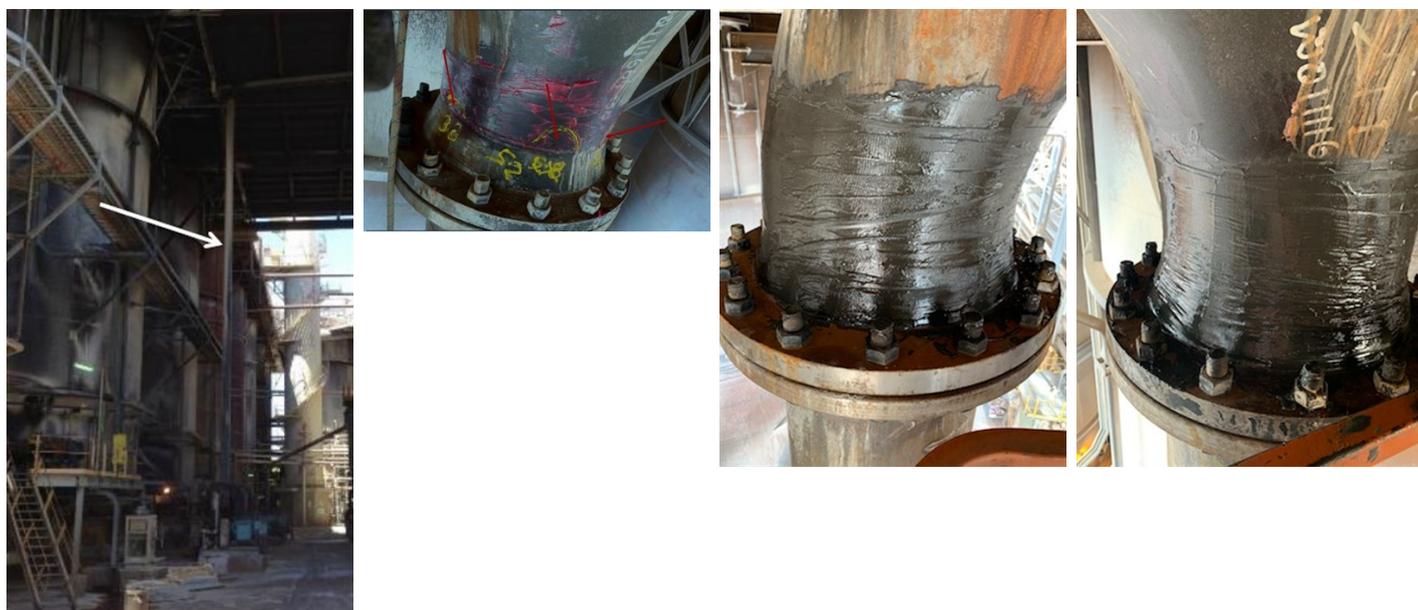
*The original wall thickness was 9.56(mm) The current thickness is around 3mm in different spots and unable to UT the weld before the neck. This is on live equipment and due to the location of the spool rope access was required.*

- \* Spool location ,
- \* Spool condition prior to repair ,
- \* Repair using 1251 and 9341 ,
- \* Repair using 1251 and 9341 ,

400NB Spool on the client's Cyclone Feed Line with an operating temperature of 80(°C) running Caustic Slurry. The pipeline in question is critical to the client, if it failed, it would mean the plant would be at half capacity.

A DRY wrap of the 9341 reinforcement tape was used to determine how much was required. A thin layer of Belzona 1251 was applied to all prepared areas pushing it well into the surface. We then Wet out a length of Belzona® 9341 with Belzona 1251. The tape coated side down to the repair was wrapped firmly around the pipe until 1251 is forced through to the outer surface. We applied a further layer of Belzona 1251 at approximately 6mm thick to completely seal the surface.
