Belzona 1251 Prevents Major Plant Shutdown

ID: 8281

400NB Spool on the client's Cyclone Feed Line with an operating temperature of 80(°C) running Caustic Slurry. The pipeline in question is critical to the client, if it failed, it would mean the plant would be at half capacity.

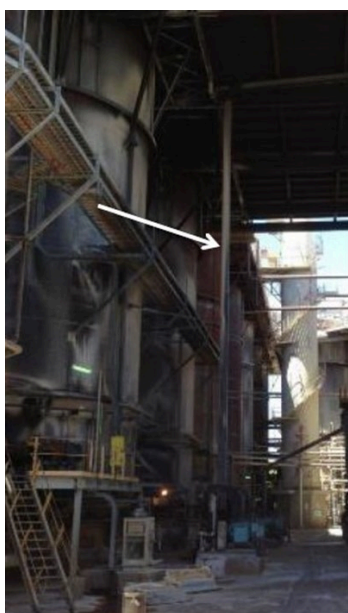
- * Spool location ,
- * Spool condition prior to repair ,
- * Repair using 1251 and 9341 ,
- * Repair using 1251 and 9341 ,

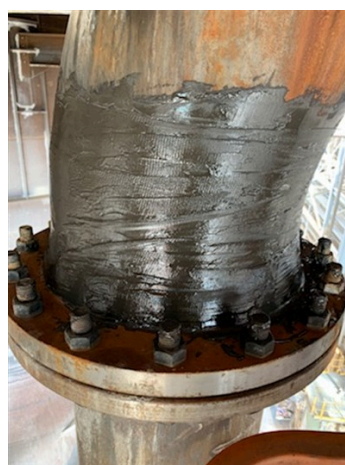
The original wall thickness was 9.56(mm) The current thickness is around 3mm in different spots and unable to UT the weld before the neck. This is on live equipment and due to the location of the spool rope access was required.
