# Tube sheet engine cooling exchanger protection with Belzona

Industry: Power  
Application: HEX-Heat Exchangers  
Substrate: Steel  
Products: \* Belzona 1111 (super metal) ,  
\* Belzona 4311 (Magma CR1) ,

Customer Location: Nuclear electric power plant in Slovakia.  
Application Date: 2018, 2019, 2020

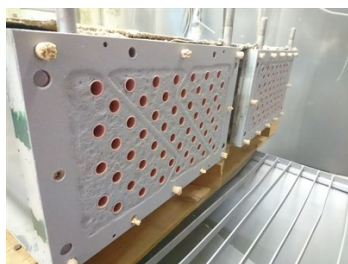
*These strong acids even if they are diluted cause big corrosion.*

The nuclear electric power plant needs to cool some engines by these exchangers (water - inlet 33°C outlet 50°C / air - inlet 110 °C). They have problems after cleaning process, because they use cleaners which content formic, phosphoric and hydrofluoric acids.
