# Belzona Sealing of Drain Outlets on Engineering Workshop Roof

ID: 8284

Customer Location: *University Campus, North Wales*  
Application Date: *February 2020*

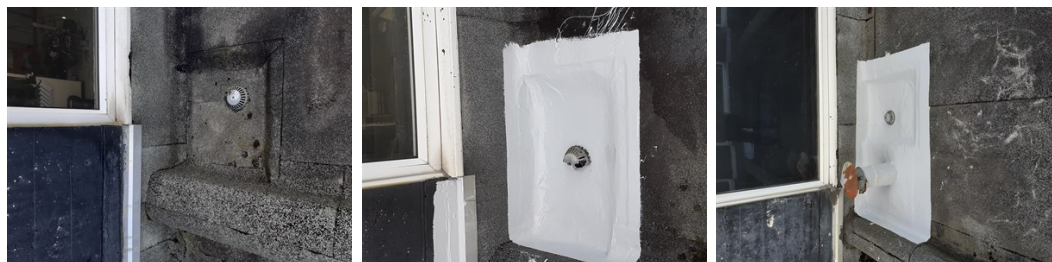
*The roof had been suffering from water ingress from its roof top drain outlets.*

- \* Example of prepared area ready for repair ,
- \* Completed application ,
- \* Completed application ,

The application was carried out in accordance with Belzona Know-How System Leaflet RPA-8. The leaking areas were cleaned down using a wire brush. The repair areas were then taped up to ensure an aesthetically pleasing finish. A first coat of Belzona 3131 was applied incorporating Belzona 9351 reinforcing sheet. As soon as the first coat was cured a second coat was applied to each area and the tape was removed.
