BELZONA 5871 PROTECTS STEAM PIPING HAZARDOUS TO OPERATORS

ID: 8288

Industry: Pulp & Paper
Application: VPF-Valves, Pipes and Fittings
Substrate: Steel
Products: * Belzona 5871 ,

Customer Location: Alabama, USA
Application Date: May, 2020

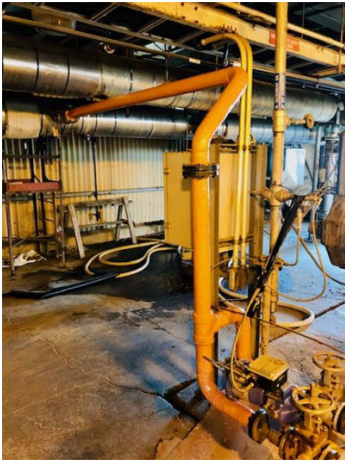
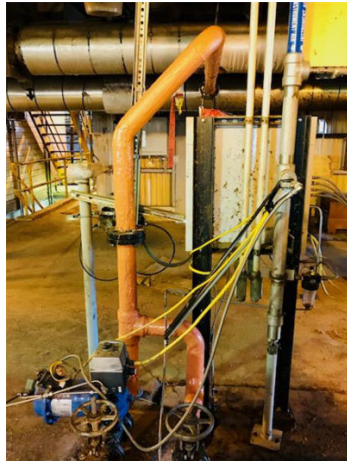
- * Pipe coated with Belzona 5871 ,
- * Pipe coated with Belzona 5871 ,
- * Measuring temperature after application of Belzona 5871 ,
- * Measuring temperature after application of Belzona 5871 ,

The line was shut down for safety handling during application procedure. Belzona 5871 was applied in 4 coats in one day, with a total DFT of 160-180 mils.

were applied in one day, and 4 more identical pipe sections were repaired during a planned maintenance. Belzona was able to reduce the temperature down to 110F, preventing any type of contact surface burn and protecting the pipe against future corrosion degradation.
