BELZONA 5871 PROTECTS STEAM PIPING HAZARDOUS TO OPERATORS

ID: 8288

Industry: Pulp & Paper
Application: VPF-Valves, Pipes and Fittings
Substrate: Steel
Products: * Belzona 5871 ,

Customer Location: Alabama, USA
Application Date: May, 2020

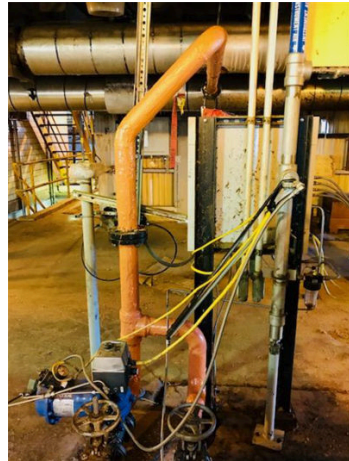
These piping sections were a potential hazard for contact burn injuries since they are located at ground level.

- * Pipe coated with Belzona 5871 ,
- * Pipe coated with Belzona 5871 ,
- * Measuring temperature after application of Belzona 5871 ,
- * Measuring temperature after application of Belzona 5871 ,

Steam piping of four identical sections of a batch digester at a local paper mill, operating at 200°F max.

The line was shut down for safety handling during application procedure. Belzona 5871 was applied in 4 coats in one day, with a total DFT of 160-180 mils.

The curing time of Belzona 5871 was accelerated because the pipe was still warm during application. All 4 layers of Belzona 5871

were applied in one day, and 4 more identical pipe sections were repaired during a planned maintenance. Belzona was able to reduce the temperature down to 110F, preventing any type of contact surface burn and protecting the pipe against future corrosion degradation.
