Belzona Restores And Protects Jet Tubes From Erosion

ID: 8290

High Speed Passenger Ferry Jet Tubes

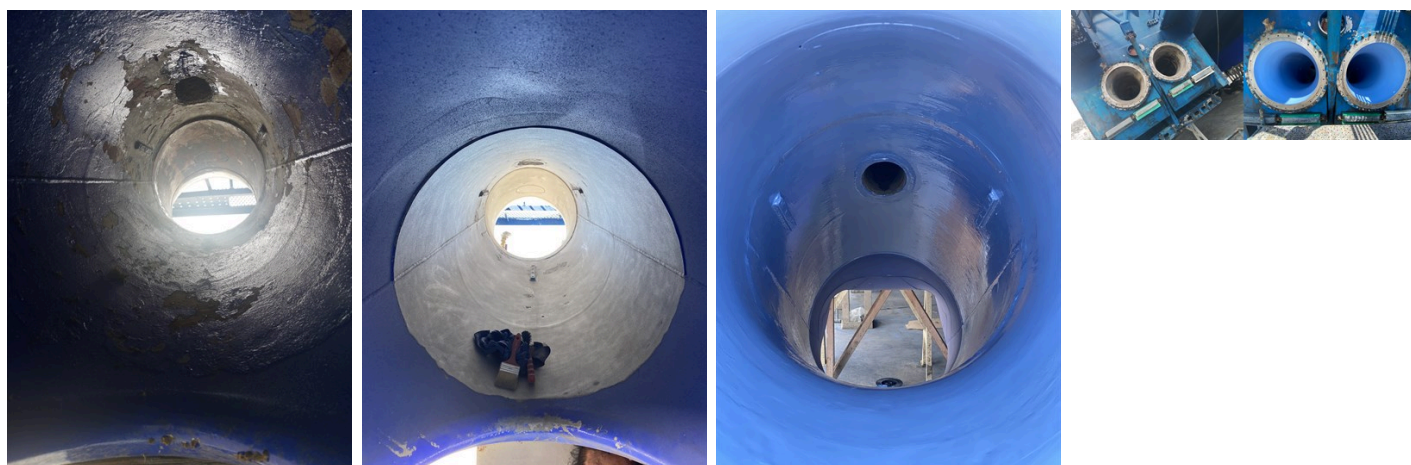
The 4 Jet Tubes presented severe pitting and cracking, due to erosion and cavitation. This existing paint system has failed locally, leading to metal loss and cracks.

- * Initial State Of Jet Tubes ,
- * Jet Tubes Blasted to Sa 2,5 ,
- * Belzona 1341 Applied ,
- * Jet Tubes Before and After Application of Belzona System ,

Application is carried out in accordance with Belzona Know-How System Leaflets SOS-1 & 2. Surface was prepared according to ISO 8501-1 Sa 2,5. All the areas suffering from pitting, cracking and metal loss, were rebuilt with Belzona 1311. Finally, two coats of Belzona 1341 were applied to the whole internal surface of the Jet Tubes, in order to provide erosion protection & water flow

optimisation.
