# Belzona protects inner wall of hot water tank

ID: 8294

Industry: Marine  
Application: TCC-Tanks and Chemical Containment Areas  
Substrate: Steel  
Products: \* Belzona 1311 (Ceramic R-Metal) ,  
\* Belzona 5892 ,

Customer Location: Shanghai  
Application Date: April 2020

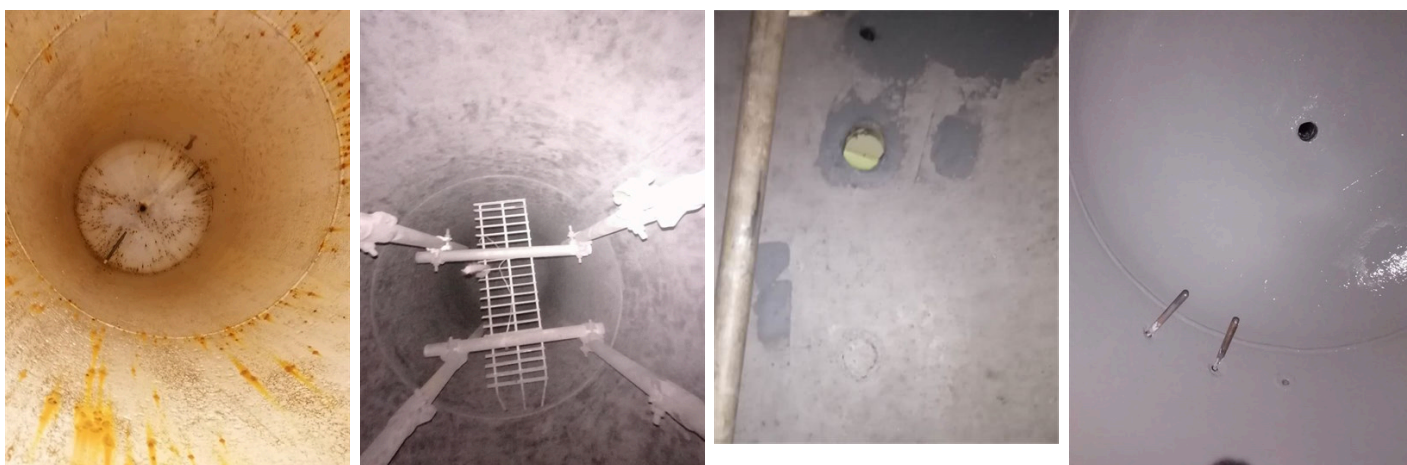
The inner wall of the tank is seriously corroded and experienced a few failed repairment, which affects the normal use of water and requires long-term anti-corrosion protection.

- \* The hot water tank before application ,
- \* Surface preparation ,
- \* Pit area filled ,
- \* Coating application complete ,

This hot water tank has been used for more than 10 years, mainly used to store and heat the freshwater made by the machine for the domestic water supply of the ship's staff. The coating has been repaired frequently. The interior is severely rusted. The thickness of the old coating is up to 1cm, accompanied by serious pit corrosion and even perforation. Internal medium: desalination of deionized water, heating, conductivity, etc.

Application was carried out in accordance with Belzona Know-How System Leaflet TCC-5 and TCC-16b. Surface preparation shall be carried out for the tank area. After sandblasted to the required roughness, clean the surface and fill the pit area with Belzona 1311. Apply the first layer of Belzona 5892 for corrosion protection, then the second layer within the overcoating window. Wait for the product to cure, and then recoat the corner areas before the application complete.
