Belzona 1212 Keeps The Dredging Pontoon Afloat

ID: 8297

Industry: Mining & Quarrying
Application: TCC-Tanks and Chemical Containment Areas
Substrate: Steel
Products: * Belzona 1212 ,

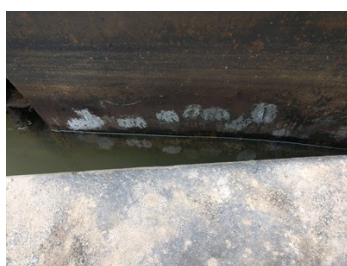
After many years of use, the pontoon on this dredge had been struck by boats and possibly run against the bank causing dents and damage to the original coating. Over time this caused corrosion and developed holes allowing water to leak into the pontoon. Due to the original coating being coal tar, and the location of the holes, welding was not a safe option. The leaks into the pontoon had grown enough to the point that in order to keep the dredge afloat, the pontoon had to be pumped out at the end of every shift.

- * Google view of the dredge ,
- * The damaged areas prepped ,
- * Application completed ,

section out of the water, and expose it for the application. A grinder was used to remove the original coating and corrosion and leave the surface very rough. Belzona 1212 was then mixed and applied over the prepared areas. The dredge was then put back into operation and the hopper was emptied which immediately returned the pontoon to its normal position with the repaired sections underwater.
