Belzona 1212 Keeps The Dredging Pontoon Afloat

ID: 8297

Sand and gravel dredge.

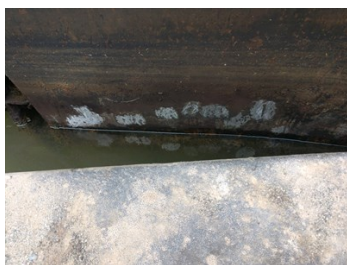
After many years of use, the pontoon on this dredge had been struck by boats and possibly run against the bank causing dents and damage to the original coating. Over time this caused corrosion and developed holes allowing water to leak into the pontoon. Due to the original coating being coal tar, and the location of the holes, welding was not a safe option. The leaks into the pontoon had grown enough to the point that in order to keep the dredge afloat, the pontoon had to be pumped out at the end of every shift.

- * Google view of the dredge ,
- * The damaged areas prepped ,
- * Application completed ,

section out of the water, and expose it for the application. A grinder was used to remove the original coating and corrosion and leave the surface very rough. Belzona 1212 was then mixed and applied over the prepared areas. The dredge was then put back into operation and the hopper was emptied which immediately returned the pontoon to its normal position with the repaired sections underwater.
