# Belzona 1212 Keeps The Dredging Pontoon Afloat

ID: 8297

Customer Location: *NW Washington*  
Application Date: *7/2020*

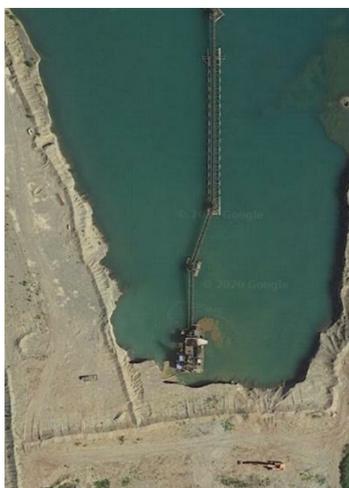
- \* Google view of the dredge ,
- \* The damaged areas prepped ,
- \* Application completed ,

section out of the water, and expose it for the application. A grinder was used to remove the original coating and corrosion and leave the surface very rough. Belzona 1212 was then mixed and applied over the prepared areas. The dredge was then put back into operation and the hopper was emptied which immediately returned the pontoon to its normal position with the repaired sections underwater.

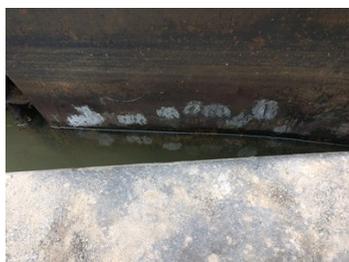
*After many years of use, the pontoon on this dredge had been struck by boats and possibly run against the bank causing dents and damage to the original coating. Over time this caused corrosion and developed holes allowing water to leak into the pontoon. Due to the original coating being coal tar, and the location of the holes, welding was not a safe option. The leaks into the pontoon had grown enough to the point that in order to keep the dredge afloat, the pontoon had to be pumped out at the end of every shift.*
