BELZONA® 1811 KEEPS THE MILLS WORKING

Application: *SHM-Solids Handling Machinery*

Customer Location: *Fossil fuel power station*

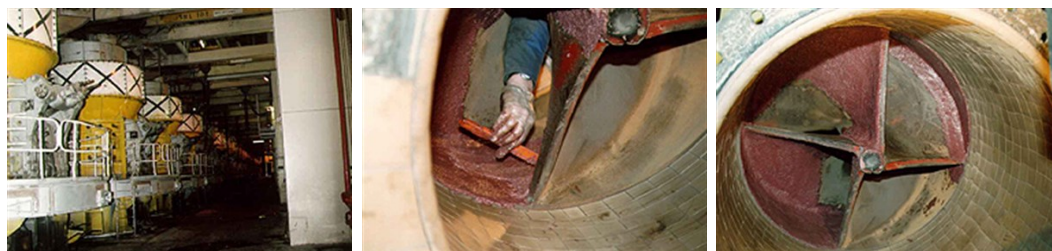
Photograph Descriptions

Severe erosion of spinner blades caused by high velocity coal dust.

- * General view of the coal mills ,
- * Application of Belzona® 1811 being undertaken in the confined spaces ,
- * The completed application with Belzona® 1811 used to restore original profiles in localised erosion areas ,

Swirl inducers (spinners) in coal mill. The spinners help improve efficiency in pneumatic handling of pulverised fuel.

Application carried out in accordance with Belzona System leaflets SHM-11 and SHM-13.

Alternative repairs by welding take several days to complete and cost £18,000, Belzona repairs are carried out at a fraction the cost.
