Belzona 1381 tank protection

ID: 8301

Application: TCC-Tanks and Chemical Containment Areas

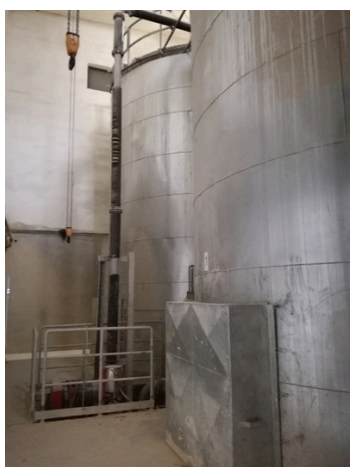
- * Two tanks are bigger ,
- * Fluid flow mix ,
- * Tank was blasted and cleaned ,
- * Second layer of Belzona 1381 ,

This customer uses 3 tanks with a fluid flow mix. 2 tanks are bigger, last one is smaller.

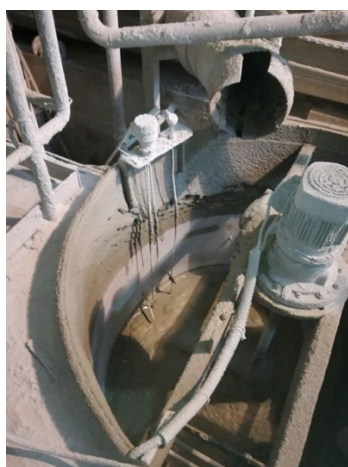
The problem was an abrasion from water (with salt - CaCl_2 , CaSO_4 , CaOH , MgOH ...) + silica sand. They missing 3,5 mm of the wall (at the bottom of the tank) after 4 years of production.

These tanks were blasted and cleaned. Two coats of Belzona 1381 were applied by spraying. The application was done in accordance with Belzona System Leaflet TCC-5.
