Belzona SuperWrap II Patch Repair on Tank

ID: 8304

Customer Location: Caronno Pertusella, Italy

Application Date: 2020

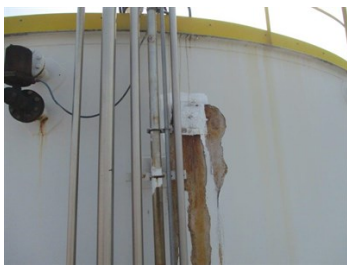
External corrosion on the exterior of a tank causing a loss in material substrate.

- * Defect zone ,
- * Up close of the defect zone ,
- * After mechanical preparation ,
- * Final application ,
