# Paving slab walkway repair with Belzona

ID: 8305

Application: FPA-Floor Problem Areas

Substrate: Stone Paving Slabs

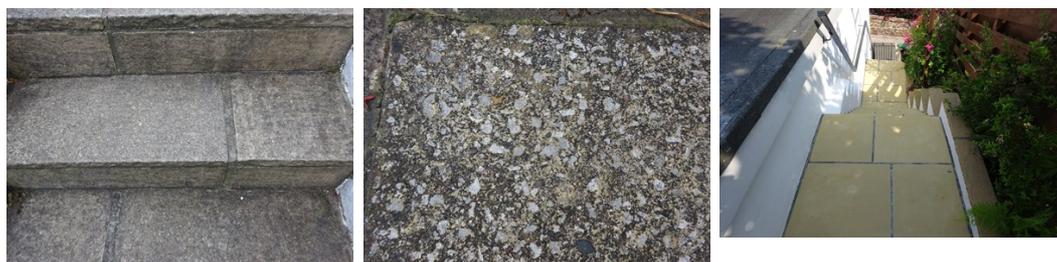
- \* Paving slabs original ,
- \* Wear & weathering of the existing slabs ,
- \* Belzona 4111 colour matched & applied ,

Marshalls paving slabs had been installed on a domestic walkway as step treads. These slabs had started to deteriorate through wear, age & weathering. The slabs had lost their original colour & now had a dull appearance. The slabs were then replaced at the expense of the installer but after a further six years the replacements had also deteriorated. A permanent solution was required.

The Belzona 4111 Base was colour matched to the original Marshalls paving slabs using the Grey/Sandstone shades & cement pigments. Belzona 4911 TX Conditioner was applied to the areas followed by the mixed Belzona 4111 Magma Quartz.

By using the Belzona solution there was no need for the removal of the existing paving slabs. These slabs could remain in place whilst being protected by a hard wearing & aesthetically pleasing material.
