Paving slab walkway repair with Belzona

ID: 8305

Application: FPA-Floor Problem Areas

Substrate: Stone Paving Slabs

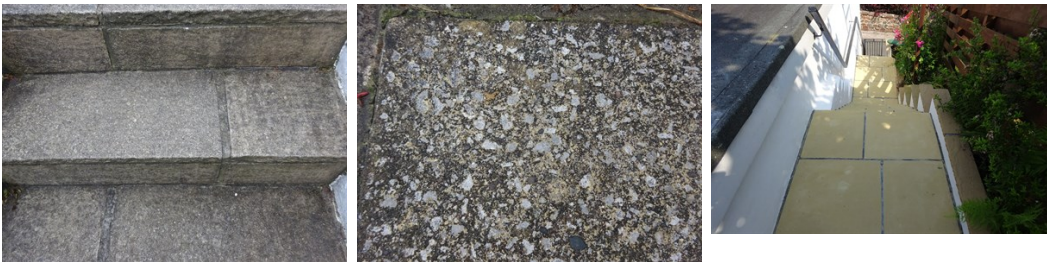
Photograph Descriptions

- * Paving slabs original ,
- * Wear & weathering of the existing slabs ,
- * Belzona 4111 colour matched & applied ,

Marshall's paving slabs had been installed on a domestic walkway as step treads. These slabs had started to deteriorate through wear, age & weathering. The slabs had lost their original colour & now had a dull appearance. The slabs were then replaced at the expense of the installer but after a further six years the replacements had also deteriorated. A permanent solution was required.

The Belzona 4111 Base was colour matched to the original Marshall's paving slabs using the Grey/Sandstone shades & cement pigments. Belzona 4911 TX Conditioner was applied to the areas followed by the mixed Belzona 4111 Magma Quartz.

By using the Belzona solution there was no need for the removal of the existing paving slabs. These slabs could remain in place whilst being protected by a hard wearing & aesthetically pleasing material.
