# Pump Repair and Protection with Belzona 1814

Application: SHM-Solids Handling Machinery

Rebuilding and protecting a pump for a shipyard.

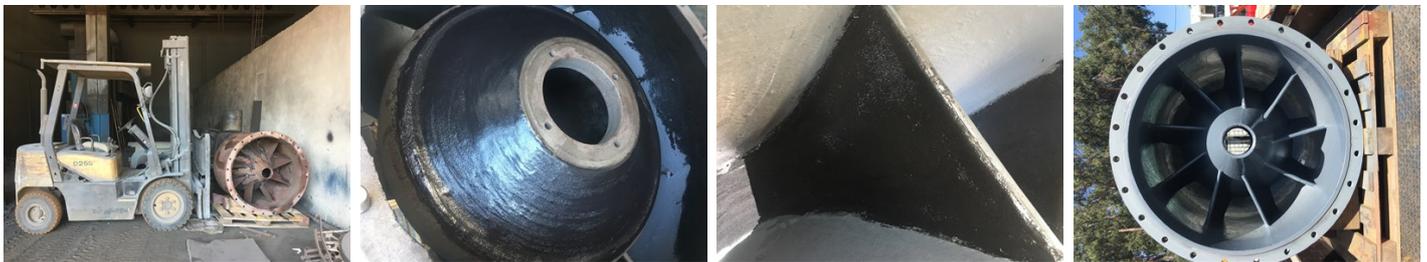
The pump was suffering from corrosion and also abrasion/erosion from the entrained solids within the process, this was causing a loss in pump efficiency.

- \* Before application ,
- \* Rebuilding body of the pump with Belzona 1814 ,
- \* Rebuilding pump vanes with Belzona 1814, other sections rebuilt with Belzona 1311 ,
- \* Final application - 2 coats of Belzona 1321 ,

The application was carried out in accordance with Belzona Know-How System Leaflet SHM-11. The whole interior and exterior of the pump was grit blasted to SA 2.5. Once grit blasted, the vanes and the center section of the pump were applied with Belzona 1814 as these area was where the most severe abrasion/erosion was occurring. The other less severe areas were rebuilt with Belzona 1311. Once the rebuilding with Belzona 1814 & 1311 was done the whole interior section of the pump was coated with 2 coats of Belzona 1321 for added erosion and corrosion protection.
