# Belzona Repairs Screw Feed Trough

ID: 8315

Restoration of a screw feed trough used for waste management.

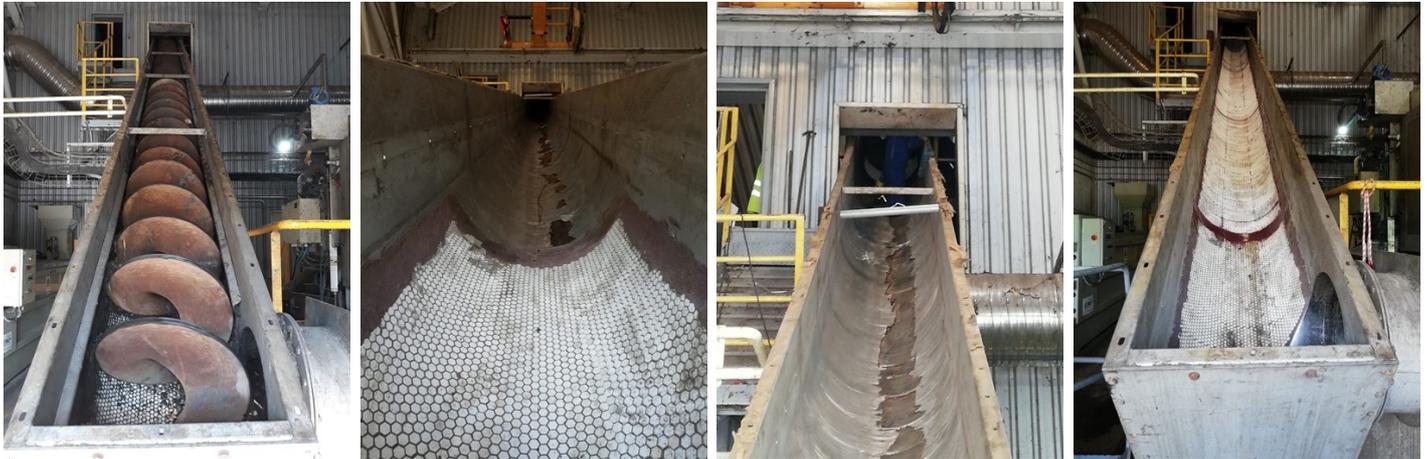
*This screw conveyor was used for the movement and separation of media such as glass, plastics and general waste for a landfill site. The harsh media going through the screw conveyor was causing severe abrasion on the screw feed trough leading to regular cracks and repairs through welding, this meant massive regular downtime for the client and they wanted to find a long term solution.*

- \* Before application - Previous 1.5m trial section can be seen at the bottom of the feed ,
- \* Close up of the 1.5m trial patch after 6 months in service ,
- \* Start of preparation and application of the Belzona 1814 section ,
- \* Final applicaiton ,

This application was carried out in accordance with a modified version of system leaflet SMH-07. The surface of the screw feed trough was prepared and cleaned before the top section of the trough was applied with Belzona 1814, the majority of the trough was then applied with Belzona 1811. The Belzona 9811 alumina tiles were also incorporated with the Belzona 1811 and Belzona 1814 to create a high abrasion resistant system.

It was agreed a 1.5m trial application would be carried out before the whole screw conveyor was to be repaired as this was the client's first time using Belzona. 6 months after the original trial the results showed the Belzona system to still be in excellent service condition. The client was extremely happy with the results and agreed to proceed with the whole screw conveyor. To follow the strict time scale the whole application was carried out in 2 days and a total of 180Kg of Belzona 1811 and 1814 was used.
