# Belzona Upgrades Plant Room Floor

ID: 8318

Industry: Buildings & Structures  
Application: FPA-Floor Problem Areas  
Substrate: Concrete  
Products: \* Belzona 5231 (SG Laminate) ,

Customer Location: Italy  
Application Date: 2016

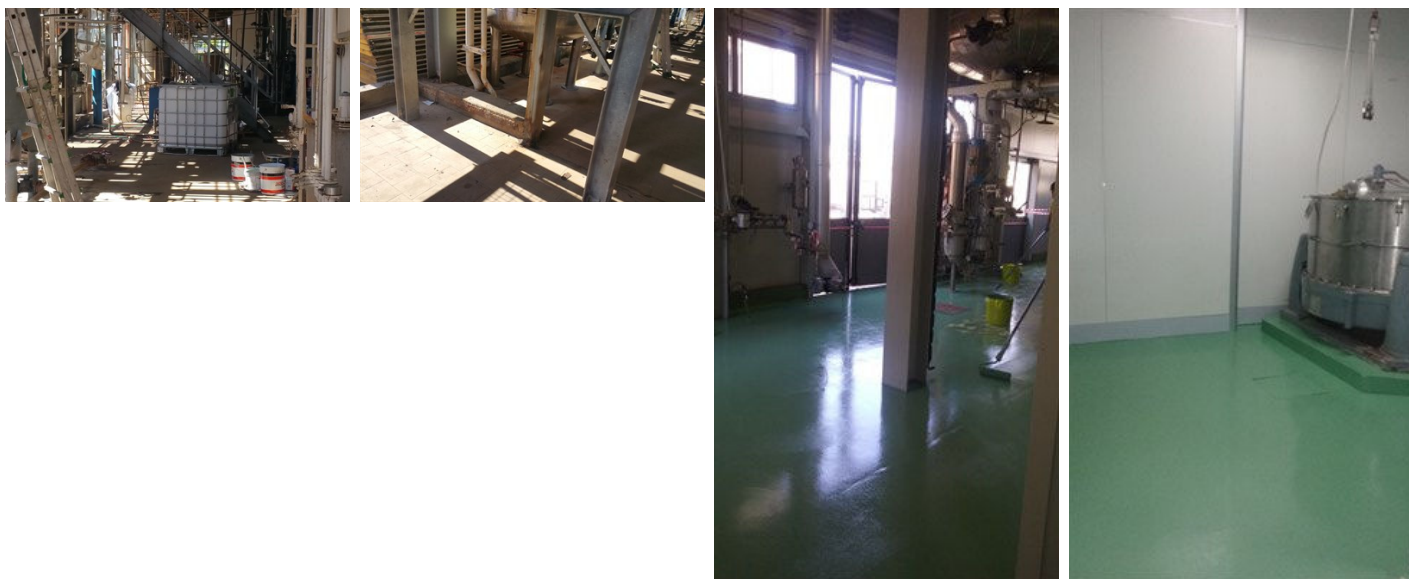
The area of the plant being extended was likely to be exposed to spillages in the future and therefore caused potential health and safety concerns for the workers.

- \* Before application - Extension of plant room ,
- \* Before application ,
- \* Belzona 5231 being applied by rollers ,
- \* Final application ,

This application was carried out in accordance with Belzona system leaflet FPA-03. The new concrete where the plant room was being extended was ground, cleaned and any loose contaminants were removed from the surface of the concrete. Once the

concrete was prepared the Belzona 5231 was applied using rollers.
