# Rubber lined ionization chamber repaired with Belzona

Problem Damage of the original rubber lining of an ionization tower Customer Location: *pharmaceutical manufacturer Hungary* Application Date: *March 2020*

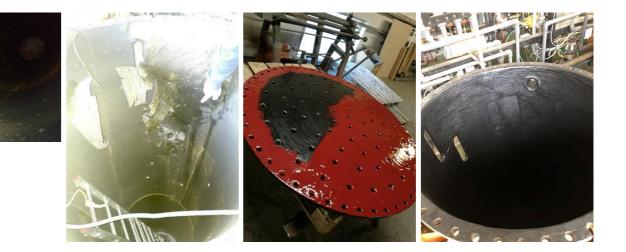
- \* Damaged rubber lining ,
- \* Removing of damaged lining and surface preparation ,
- \* Second layer of 2121 is being applied ,
- \* Finished application ,

Damaged rubber lining has been removed and MBX was used to abrade the surface. Loosen rubber parts were cut off and 2111 was used to replace missing parts and 2121 was used to provide a long term and chemical resistant solution.
