Rubber lined ionization chamber repaired

ID: 8322

Problem

Damage of the original rubber lining of an ionization tower.

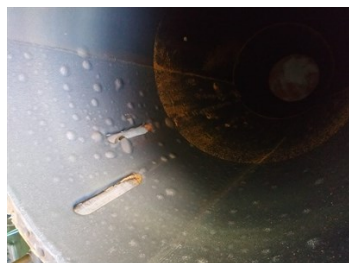
- * 1. Damaged rubber lining ,
- * 2. Removing of damaged lining and surface preparation ,
- * 3. Second layer of Belzona 2121 being applied ,
- * 4. Finished application ,
