BELZONA REPAIRS AND SECURES FLOORS AND STAIRS

Application: *FPA-Floor Problem Areas*

Customer Location: *Housing association, Georgia, US*

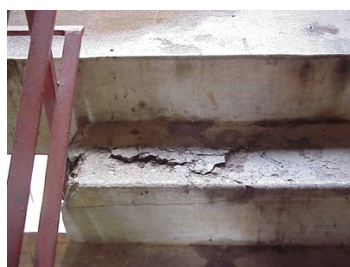
Spalled concrete due to water damage over time.

- * Damaged stairs. ,
- * Completed repairs and coating, with Belzona® 5811 mixed with a light coat of sand. Undersides of the stairwell were coated with Belzona® 3111. ,
- * Areas repaired with Belzona® 4111 & 4141. ,
- * Finished view of the project. ,
