Belzona repairs the clinker crusher rotor

Industry: *Cement*
Application: *MPT-Mechanical Power Transmission*

Customer Location: *Cement producer, Slovakia*
Application Date: *2020*

Substrate: *Steel*
Products: ** Belzona® 1111 (Super Metal) ,*

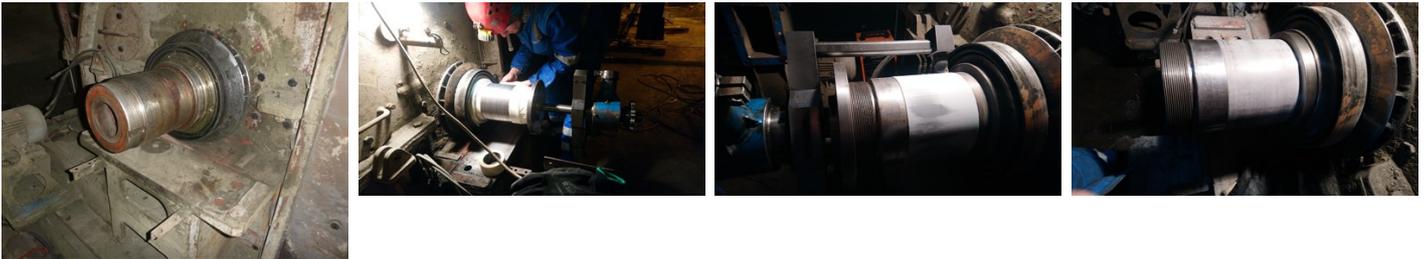
The crusher rotor was damaged due to the loading and working environment.

- * 1. Damaged rotor ,
- * 2. Rotor after machining, preparing for Belzona 1111 application ,
- * 3. Belzona® 1111 machined ,
- * 4. The rotor prepared for operation ,

Application was carried out in accordance with Belzona Know-How System Leaflet MPT-1. Hand portable lathe was used to machine the rotor.

The traditional repair using welding and subsequent grinding of the rotor should take a long time. The repair using Belzona took several days, resulting into significant savings.
