# BELZONAS OPTIMIZED BEARING INSTALLATION

ID: 834

Industry: *Marine*  
Application: *SOS-Ships and Offshore Structures*

Container Ship Rudder Bearings

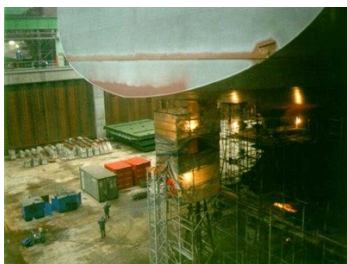
- \* Aft end of containership ,
- \* Positioning and sealing of lower annulus ,
- \* Injection of Belzona® 1321 ,
- \* Vent ports installed to ensure void free application ,

In this case the synthetic bearing was seated in a steel carrier ring. Bonding with Belzona® 1321 prevents the risk of crevice corrosion and fretting. On this vessel the stainless steel pintle liners are also bonded to prevent galvanic corrosion. Over 30 ships in this class have used this installation method in both Germany and the USA.
