BELZONAS OPTIMIZED BEARING INSTALLATION

ID: 834

Container Ship Rudder Bearings

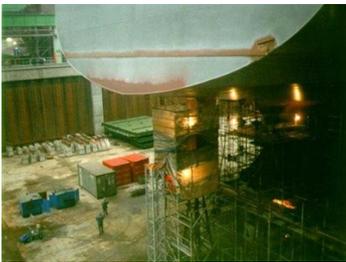
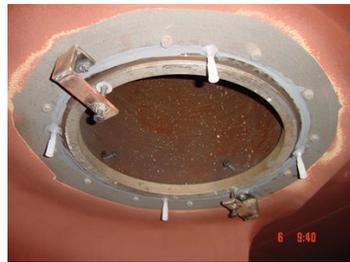
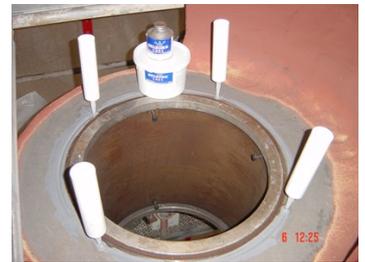
Photograph Descriptions

- * Aft end of containership ,
- * Positioning and sealing of lower annulus ,
- * Injection of Belzona® 1321 ,
- * Vent ports installed to ensure void free application ,

In this case the synthetic bearing was seated in a steel carrier ring. Bonding with Belzona® 1321 prevents the risk of crevice corrosion and fretting. On this vessel the stainless steel pintle liners are also bonded to prevent galvanic corrosion. Over 30 ships in this class have used this installation method in both Germany and the USA.
