BELZONAS OPTIMIZED BEARING INSTALLATION

Industry: *Marine*
Application: *SOS-Ships and Offshore Structures*

Container Ship Rudder Bearings

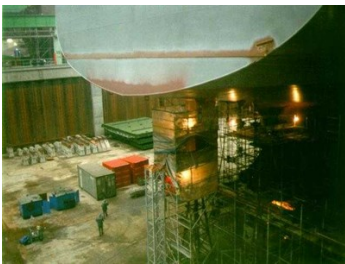
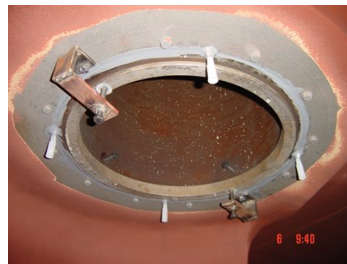
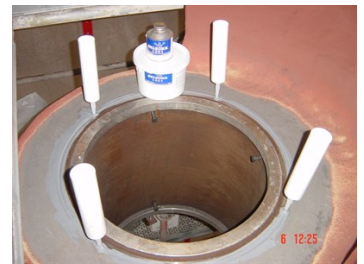
Photograph Descriptions

- * Aft end of containership ,
- * Positioning and sealing of lower annulus ,
- * Injection of Belzona® 1321 ,
- * Vent ports installed to ensure void free application ,

In this case the synthetic bearing was seated in a steel carrier ring. Bonding with Belzona® 1321 prevents the risk of crevice corrosion and fretting. On this vessel the stainless steel pintle liners are also bonded to prevent galvanic corrosion. Over 30 ships in this class have used this installation method in both Germany and the USA.

The application was carried out using a modified version of Belzona Know-How System leaflet SOS-4.
