BELZONAS OPTIMIZED BEARING INSTALLATION

ID: 834

Container Ship Rudder Bearings

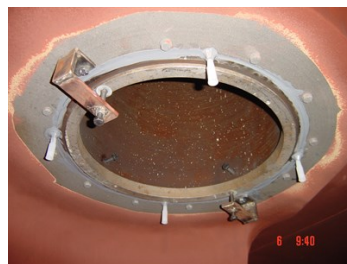
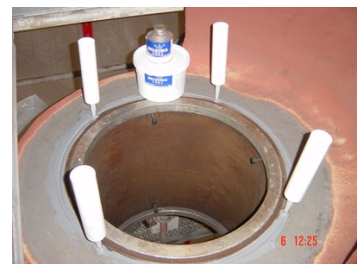
- * Aft end of containership ,
- * Positioning and sealing of lower annulus ,
- * Injection of Belzona® 1321 ,
- * Vent ports installed to ensure void free application ,

In this case the synthetic bearing was seated in a steel carrier ring. Bonding with Belzona® 1321 prevents the risk of crevice corrosion and fretting. On this vessel the stainless steel pintle liners are also bonded to prevent galvanic corrosion. Over 30 ships in this class have used this installation method in both Germany and the USA.
