Belzona Lines Internals of a Gas Main

ID: 8345

Customer Location: Steel Works, East Midlands, UK
Application Date: August 2020

Phase 5 lining of 96" site Gas main.

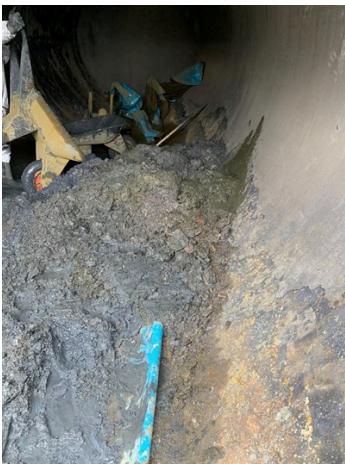
- * 1. Residue to be removed ,
- * 2. Grit Blasting ,
- * 3. Pits filled with Belzona 4154 (Bulk-Fill) ,
- * 4. Finished Application ,

The main was cleared of residue that built up over the years. The whole pipe was cleaned and blasted to an SA 2.5, 75 micron profile, ready for the Belzona application. Any holes are over plated using 150mm² plates, bonded in position with Belzona 1151. The heavily pitted areas are filled with Belzona 4154 bulk fill material. The mix was achieved using 2 x units of resin to one bag of kiln-dried sand.
