# Belzona Lines Internals of a Gas Main

ID: 8345

**Customer Location:** Steel Works, East Midlands, UK  
**Application Date:** August 2020

Phase 5 lining of 96" site Gas main.

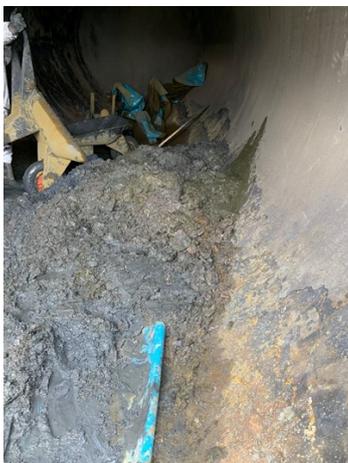
- \* 1. Residue to be removed ,
- \* 2. Grit Blasting ,
- \* 3. Pits filled with Belzona 4154 (Bulk-Fill) ,
- \* 4. Finished Application ,

The main was cleared of residue that built up over the years. The whole pipe was cleaned and blasted to an SA 2.5, 75 micron profile, ready for the Belzona application. Any holes are over plated using 150mm<sup>2</sup> plates, bonded in position with Belzona 1151. The heavily pitted areas are filled with Belzona 4154 bulk fill material. The mix was achieved using 2 x units of resin to one bag of kiln-dried sand.
