Belzona Lines Internals of a Gas Main

ID: 8345

Phase 5 lining of 96" site Gas main.

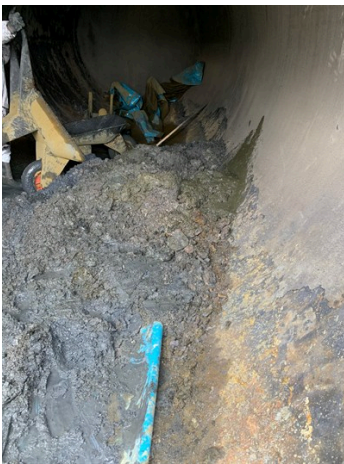
- * 1. Residue to be removed ,
- * 2. Grit Blasting ,
- * 3. Pits filled with Belzona 4154 (Bulk-Fill) ,
- * 4. Finished Application ,

The main was cleared of residue that built up over the years. The whole pipe was cleaned and blasted to an SA 2.5, 75 micron profile, ready for the Belzona application. Any holes are over plated using 150mm2 plates, bonded in position with Belzona 1151. The heavily pitted areas are filled with Belzona 4154 bulk fill material. The mix was achieved using 2 x units of resin to one bag of kiln-dried sand.
