# Belzona 2311 repairs Waste Incineration Plant Conveyor Belt

ID: 8347

Industry: Water / Wastewater  
Application: SHM-Solids Handling Machinery

Customer Location: Switzerland  
Application Date: June, 2019

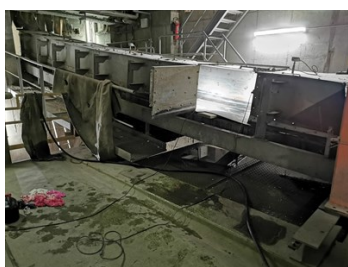
- \* Picture 1 - Conveyor System ,
- \* Picture 2 - Conveyor Belt Tear ,
- \* Picture 3 - Belzona 2311 ,
- \* Picture 4 - Application Complete ,

A conveyor belt had torn during operation within a waste incineration plant. Conveyor belts transport biomass from the waste heap to shredders or transfer stations.

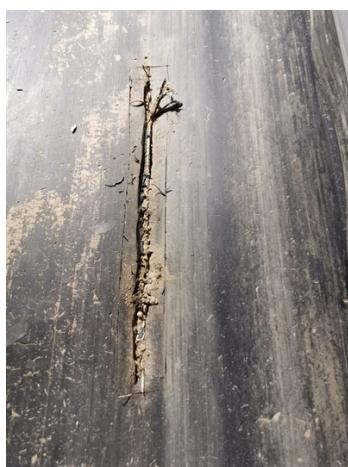
*There were a number of tears in the conveyor belts due to the medium that was being transported along the conveyors. If the belts had torn completely the waste would have spread all over the internal of the operation and also the whole plant would have to be shut down to repair.*
