REPAIR OF SEA WATER FLANGE WITH BELZONA ELASTOMER

Customer Location: SHIPYARD, TURKEY
Application Date: March 2020

Sea water flange on Ro-Ro ship.

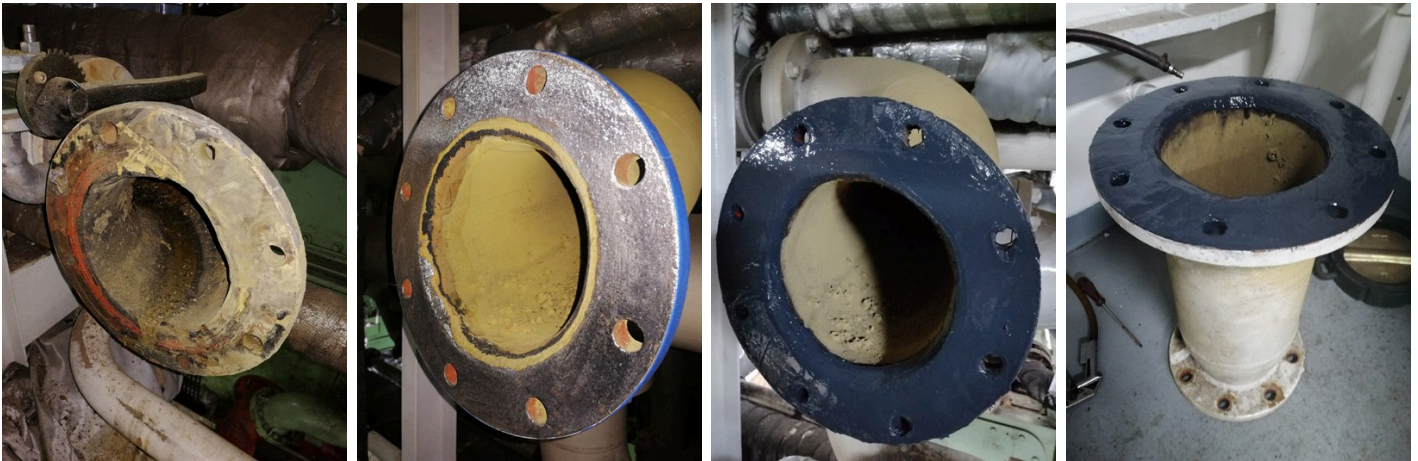
Photograph Descriptions

Seawater system flange surfaces were damaged due to corrosion and errosion.

- * 1. Damaged filter flange ,
- * 2. Abraded flange surface ,
- * 3. Application of Belzona 2211 on filter flange ,
- * 4. Application of Belzona 2211 on flange of filter connection pipe ,

Application was carried out in accordance with Belzona Know-How System Leaflet GSS-01. Damaged flange surface was abraded to achieve a mechanical bond. The surface was conditioned with Belzona 2911 and allowed the cure. Then Belzona 2211 was applied and allowed to cure.

In the tight calendar, the shipowner had no time and staff to dismantle and repair the flange. With Belzona, the repair was carried

out in-situ and quickly.
