Leaking Parapets on Grade 1 Listed Church coated with Belzona 3131

ID: 8354

Industry: *Buildings & Structures*
Application: *RPA-Roof Problem Areas*

Customer Location: *Birmingham, UK*
Application Date: *3rd August 2020*

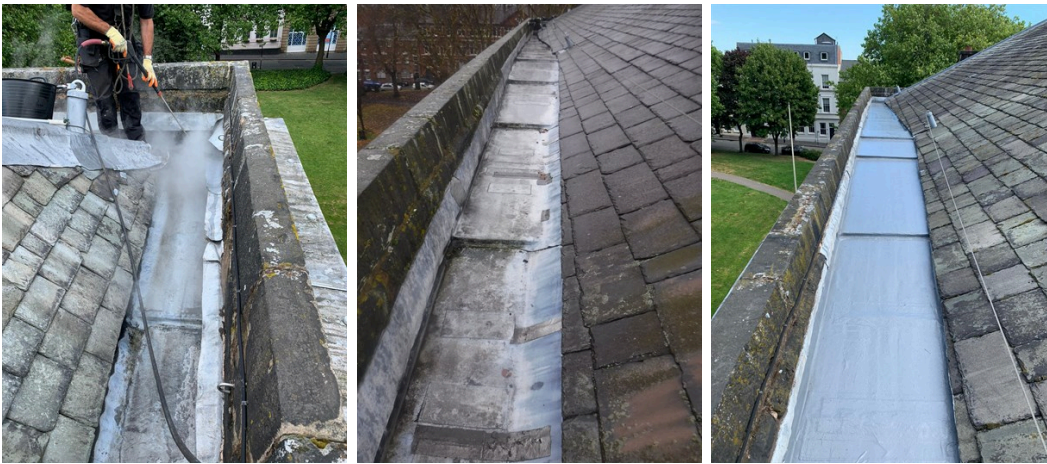
Photograph Descriptions

Water was leaking through the damaged/cracked parts of the lead parapet.

- * 1) Cleaning the substrate with Doff Cleaning machine. ,
- * 2) Lead parapet prior to application ,
- * 3) Completed Application ,

The parapet of the roof was cleaned using a Doff machine at 160 degrees. Belzona 3921 conditioner was applied to the substrate and left over night. A first coat of Belzona 3131 was applied whilst laying Belzona 9361 reinforcing sheet over the top. A second coat of Belzona 3131 applied over the top to complete the application. This was completed in accordance with Belzona System Leaflet RPA-06.
