BELZONA REPAIRS AND PROTECTS 2 STAGE SEAWATER PUMP

Application: CEP-Centrifugal Pumps

Application Date: June 2020

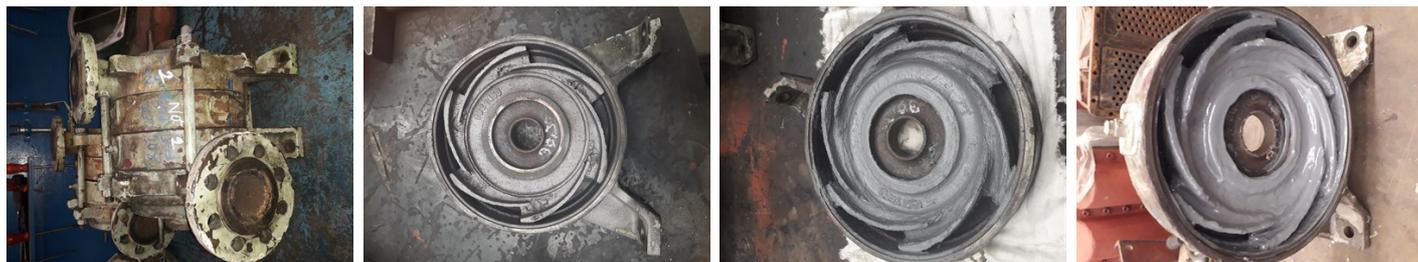
Photograph Descriptions

Pump case surface was severely damaged due to cavitation from seawater and corrosion.

- * 1. 2 stages seawater pump with high cavitation ,
- * 2. After Grit-Blasting ,
- * 3. Application of Belzona 1311 ,
- * 4. Application of Belzona 1321 ,

The application was carried out in accordance with Belzona Know-How System Leaflets CEP-03 and CEP-05. Dismantled pump casings were grit blasted to SA 2,5 Standard in the workshop blasting cabinet. All surfaces were thoroughly cleaned. Then the damaged surfaces and pittings were repaired with Belzona 1311 before coating with Belzona 1321 to provide overall erosion-corrosion protection.
