# Belzona provides a grip system for machine plinths

**Industry:** Buildings & Structures  
**Application:** FPA-Floor Problem Areas  
**Substrate:** Steel  
**Products:** \* Belzona 9111 (Cleaner Degreaser) ,  
\* Belzona 4411 (Granogrip) ,  
\* Belzona 9221 (Surefoot Aggregate White) ,

**Customer Location:** Doncaster, UK  
**Application Date:** 13th August, 2020

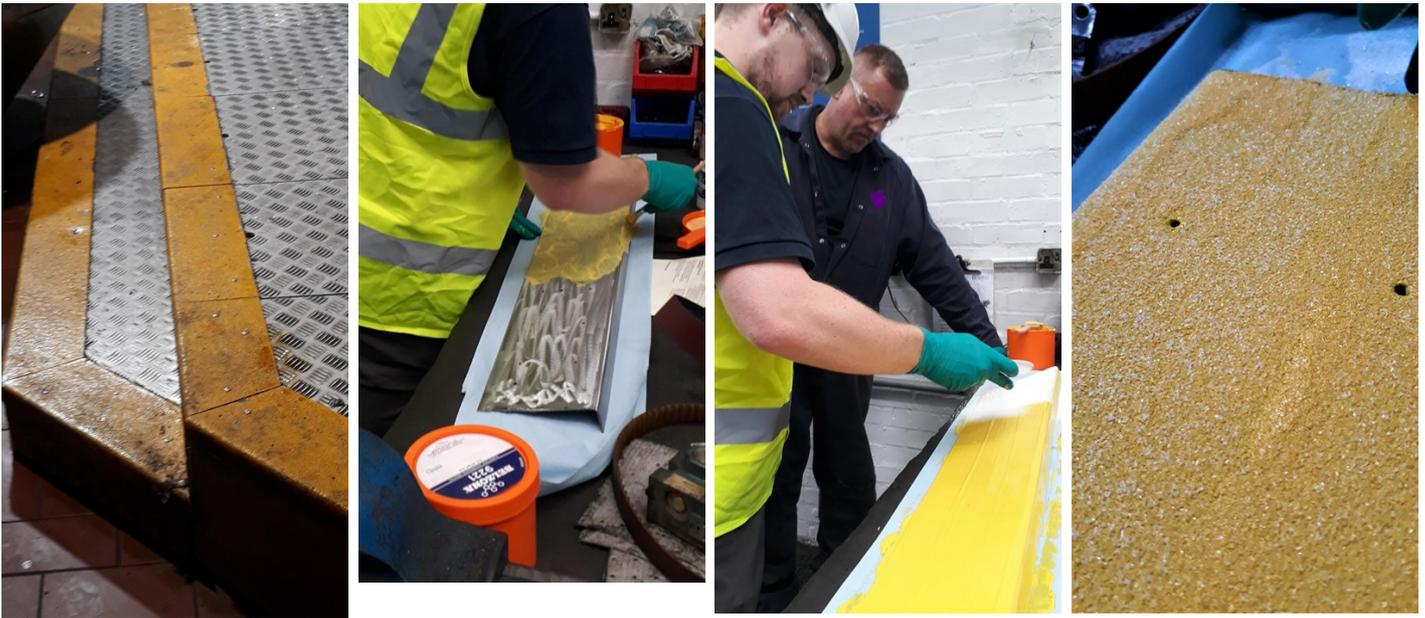
## Photograph Descriptions

The existing coating was not performing as it should and slips were being recorded

- \* 1. Plates in position with original coatings ,
- \* 2. Application of Belzona 4411 to blasted and ground steel substrate ,
- \* 3. Training taking place ,
- \* 4. Finished plate ready for installation ,

The elevated plinths used by the workforce to gain access and operate machinery in a large factory had plates fitted with a low-slip coating. This appeared to have been applied too thick and the aggregate was very deep in the coating, leaving little protrusion and therefore low-grip.

Application was completed in conjunction with Belzona System Leaflet FPA-8. Plates were removed and gritblasted in the clients own blast booth. The resultant substrate was not to the recommended profile, as it was a very fine aggregate. It was decided further preparation was required using a cutting disc. Belzona 9111 was used to degrease the plates Belzona 4411 was applied. Belzona 9221 was broadcast into the wet product, the excess being tipped into a container. Finally, the aggregate was gently pressed into the product, providing total coverage to the whole area.
