Belzona provides a grip system for machine plinths

ID: 8358

Industry: Buildings & Structures
Application: FPA-Floor Problem Areas
Substrate: Steel
Products: * Belzona 9111 (Cleaner Degreaser) ,
* Belzona 4411 (Granogrip) ,
* Belzona 9221 (Surefoot Aggregate White) ,

Customer Location: Doncaster, UK
Application Date: 13th August, 2020

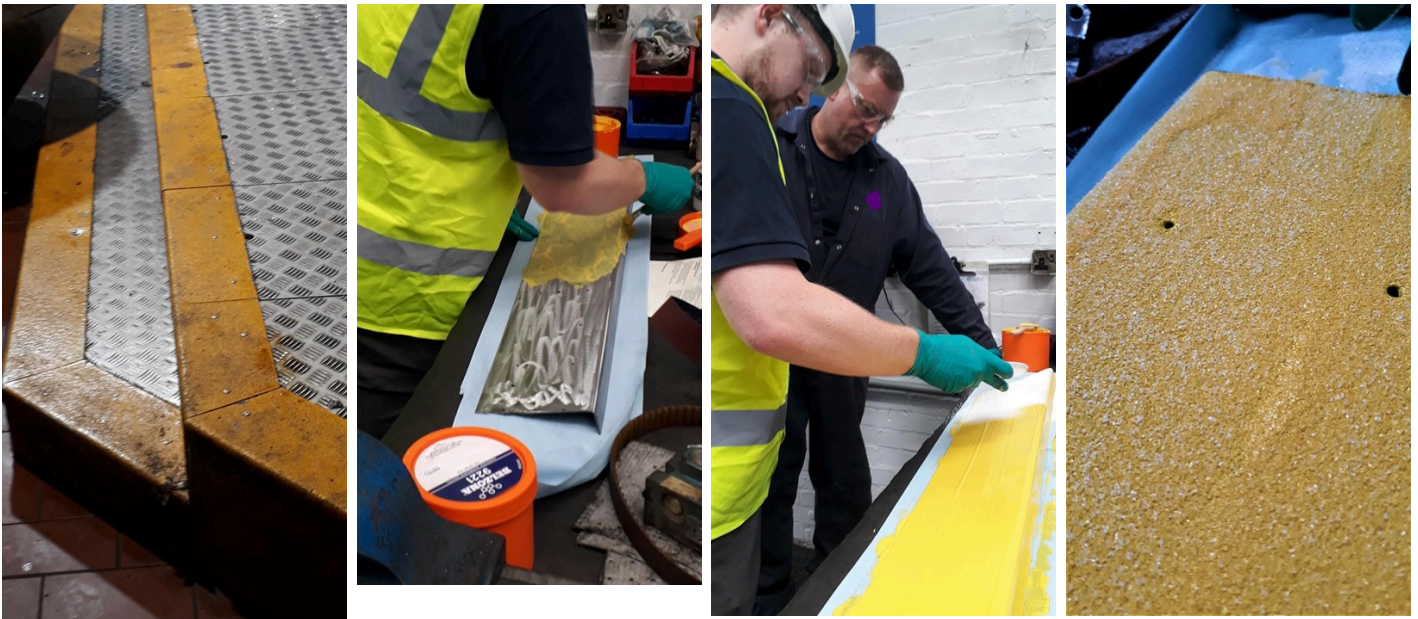
Photograph Descriptions

The existing coating was not performing as it should and slips were being recorded

- * 1. Plates in position with original coatings ,
- * 2. Application of Belzona 4411 to blasted and ground steel substrate ,
- * 3. Training taking place ,
- * 4. Finished plate ready for installation ,

The elevated plinths used by the workforce to gain access and operate machinery in a large factory had plates fitted with a low-slip coating. This appeared to have been applied too thick and the aggregate was very deep in the coating, leaving little protrusion and therefore low-grip.

Application was completed in conjunction with Belzona System Leaflet FPA-8. Plates were removed and gritblasted in the clients own blast booth. The resultant substrate was not to the recommended profile, as it was a very fine aggregate. It was decided further preparation was required using a cutting disc. Belzona 9111 was used to degrease the plates Belzona 4411 was applied. Belzona 9221 was broadcast into the wet product, the excess being tipped into a container. Finally, the aggregate was gently pressed into the product, providing total coverage to the whole area.
