BELZONA REPAIR OF FLOATING HOSES

ID: 836

Customer Location: Oil Refinery, Philippines
Application Date: March 2007

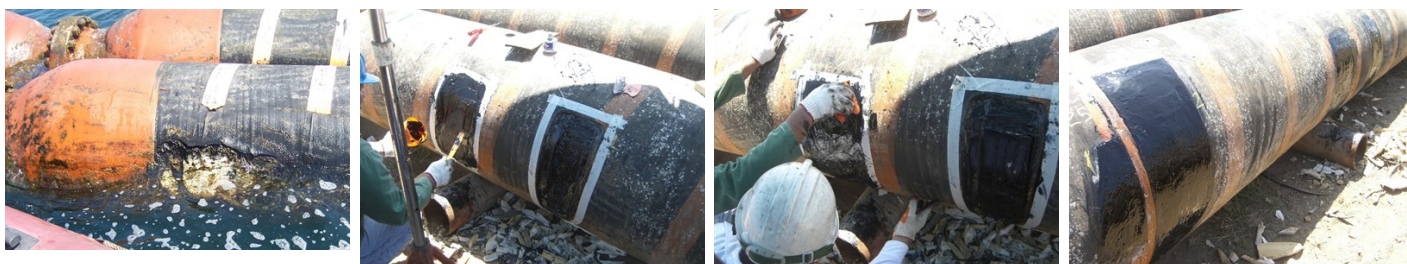
Photograph Descriptions

Rubber covers and flotation/insulation on fuel hoses was damaged by ships propeller during fuel loading and unloading.

- * Typical damage ,
- * New insulation being bonded in with Belzona ,
- * Final outer cover build-up and coating ,
- * Completed repair ,

The repair was carried out in accordance with Belzona Know-How System Leaflet SOS-12.
